# CONCRETE CANVAS™

## BUND LINING

## 07.06.11 Slope Stabilisation Case Study : Classified

## 26.05.11 Case Study : Departamento del Meta, Colombia

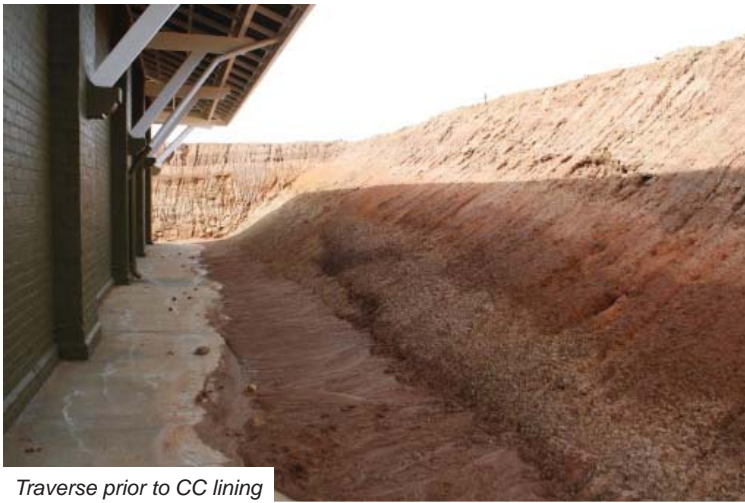
Traverse prior to CC lining

The traverse batters were excavated to a maximum of 30° to the vertical ensuring surface flow was directed into the 600mm wide spoon drains at the base of the bund. A 50mm sand base course was applied to the traverse prior to the installation of the CC to allow free drainage. The CC was supplied as 200sqm bulk rolls and installed on site using plant mounted spreader beams. The material was unrolled into position and fixed into the batters using 500mm soil pins with washers. Each CC layer was anchored top and toe of the batter by a minimum of 300mm and overlapped 100mm between adjacent sheets. Weep holes were drilled into the base of the Canvas at 3m centres once the CC had set.

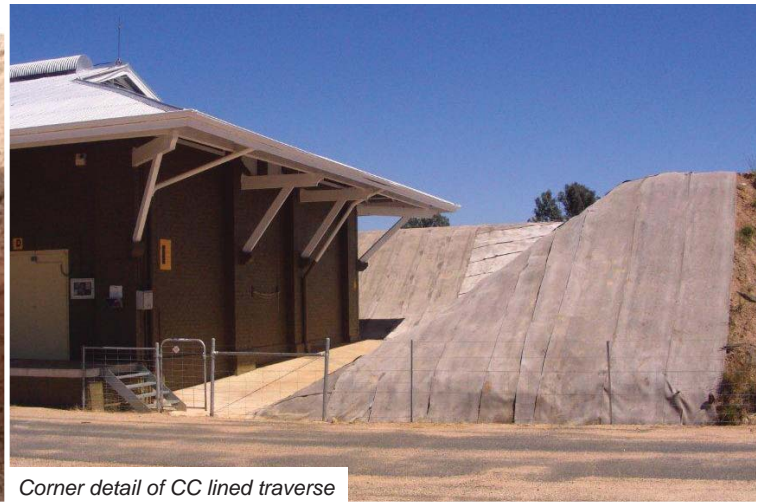
Corner detail of CC lined traverse

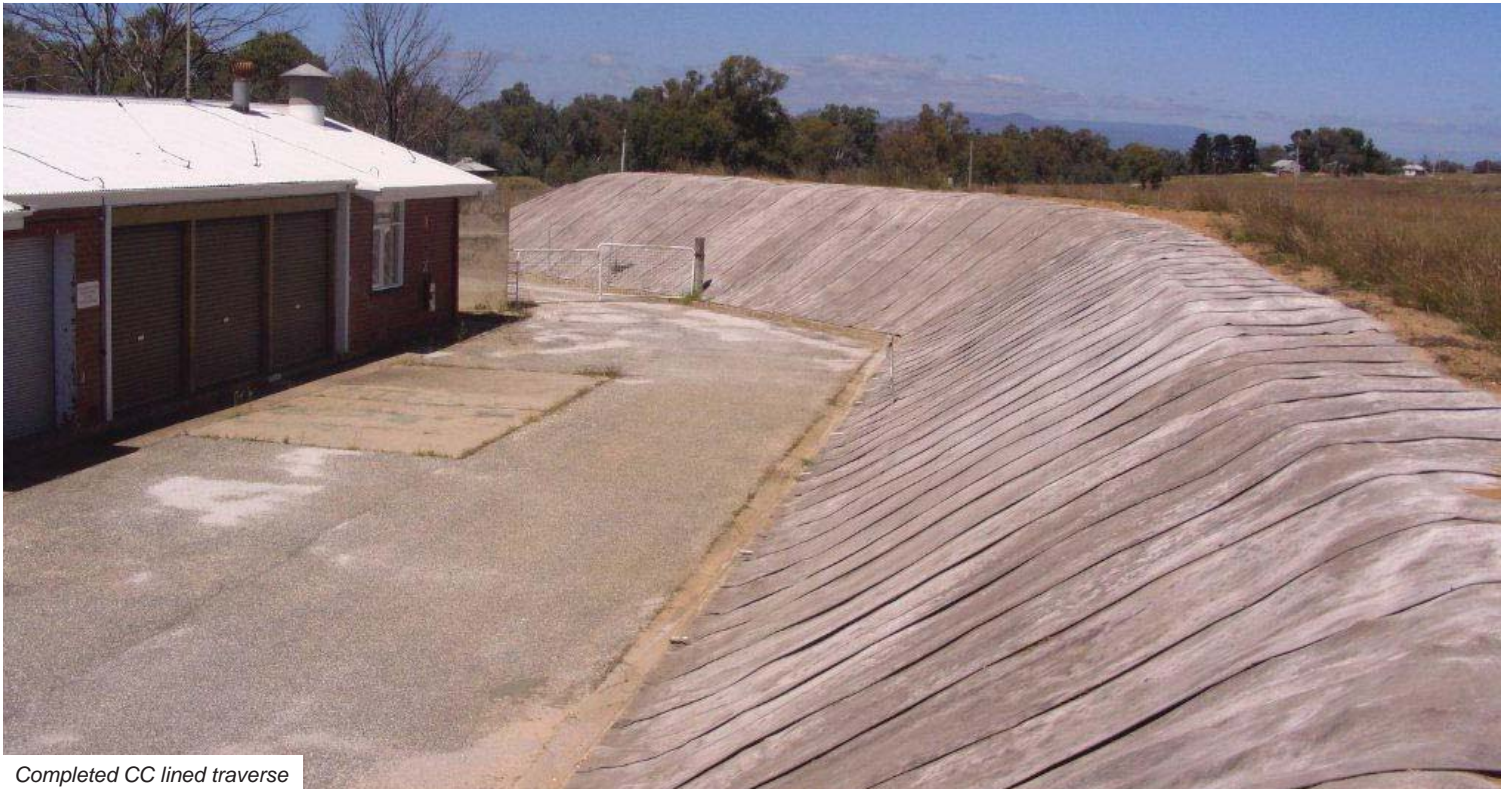
Completed CC lined traverse

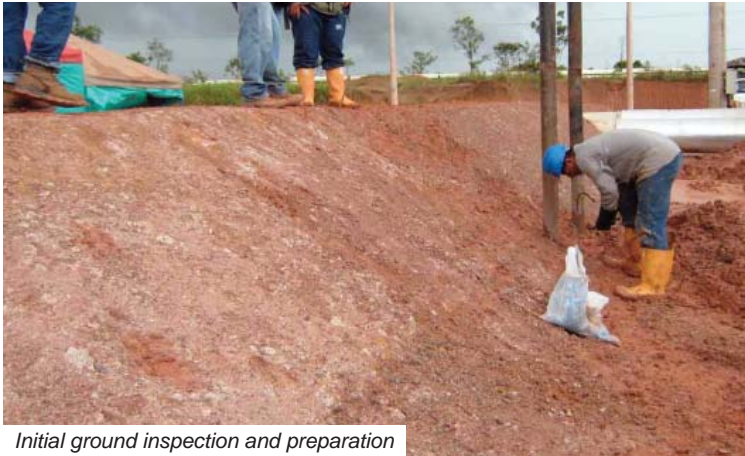
Initial ground inspection and preparation

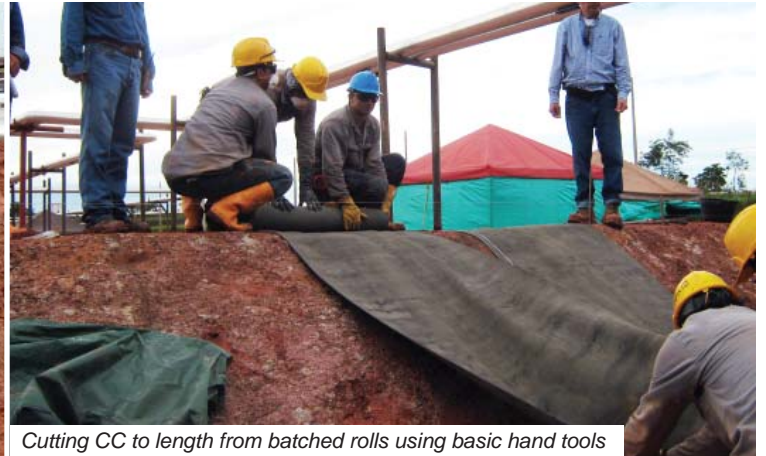
Cutting CC to length from batched rolls using basic hand tools

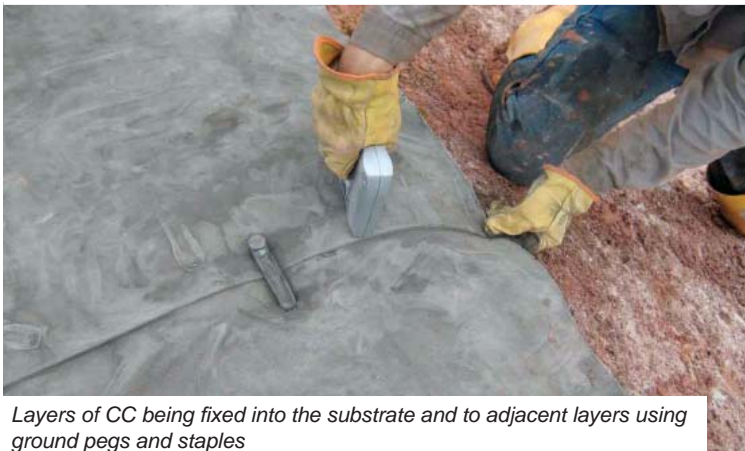
Layers of CC being fixed into the substrate and to adjacent layers using ground pegs and staples

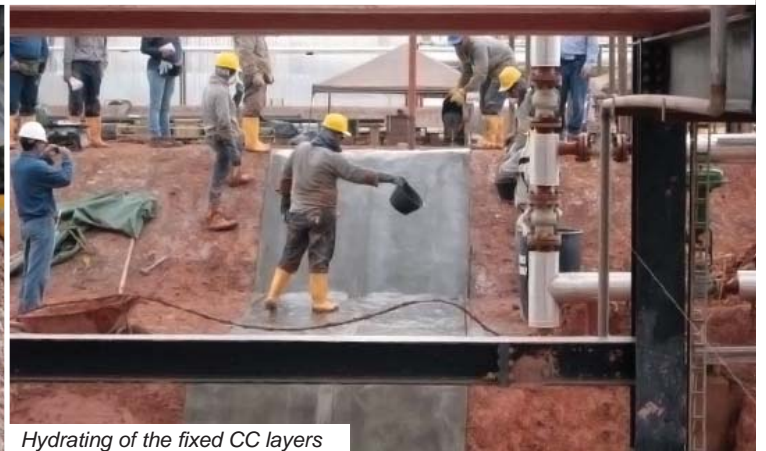
Hydrating of the fixed CC layers

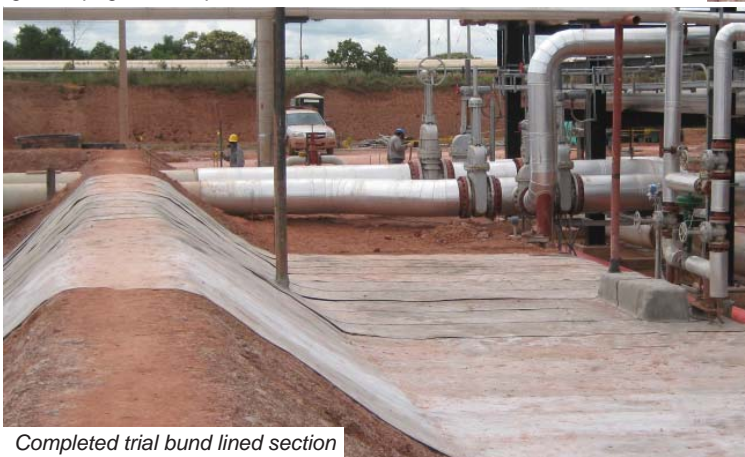
Completed trial bund lined section

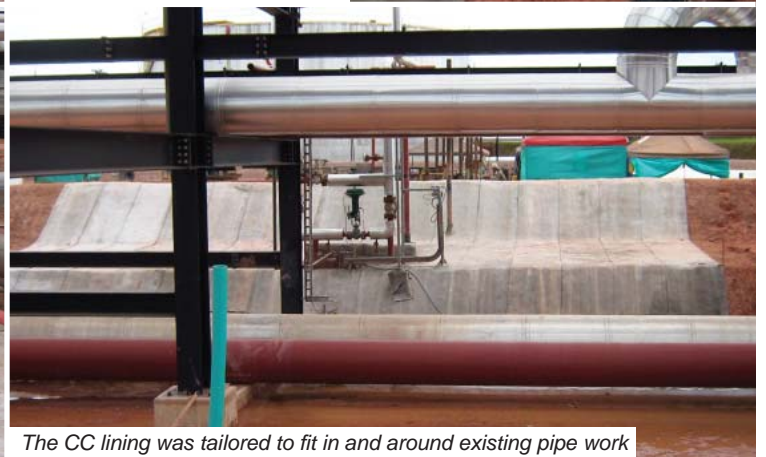
The CC lining was tailored to fit in and around existing pipe work
