# CONCRETE CLOTH™

## SLOPE PROTECTION

### 21.12.10 Case Study : Alcobendas Station, Madrid, Spain

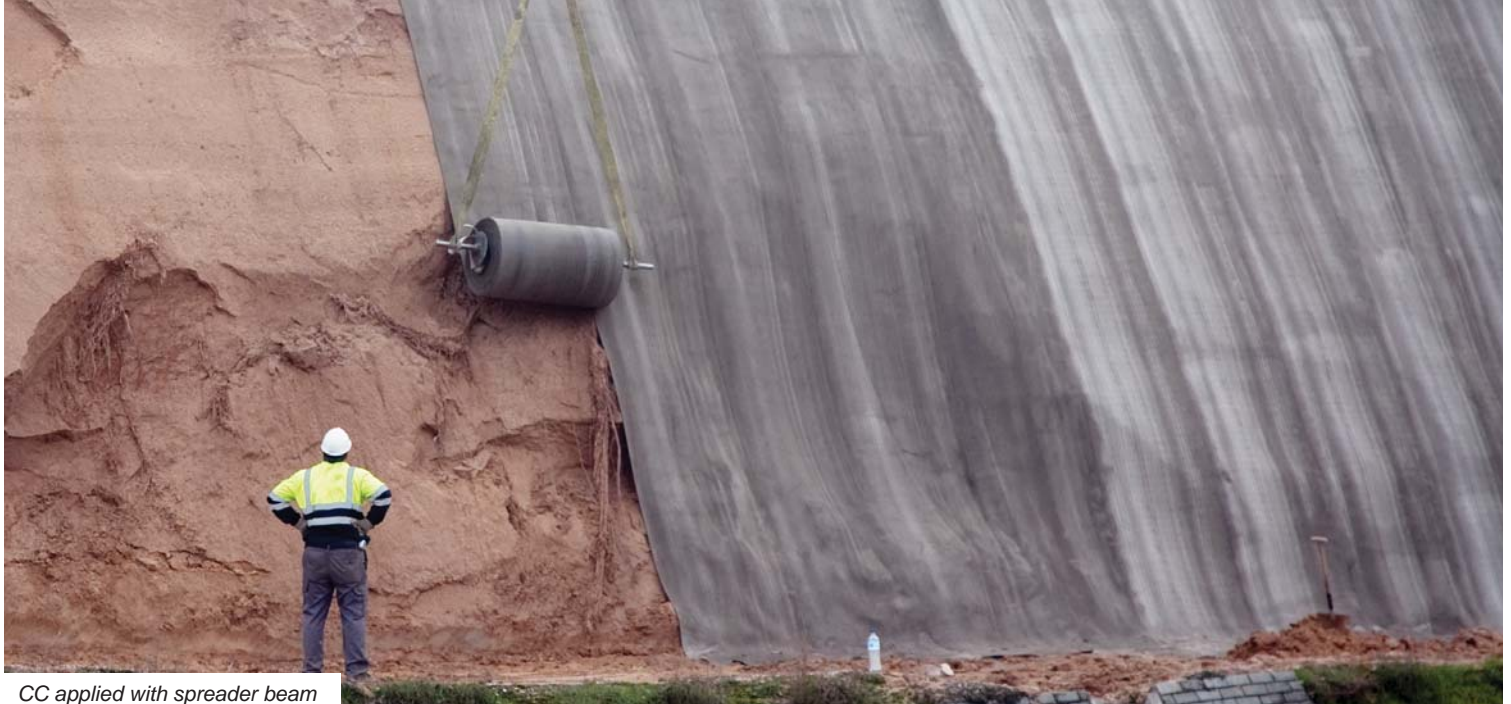
CC applied with spreader beam

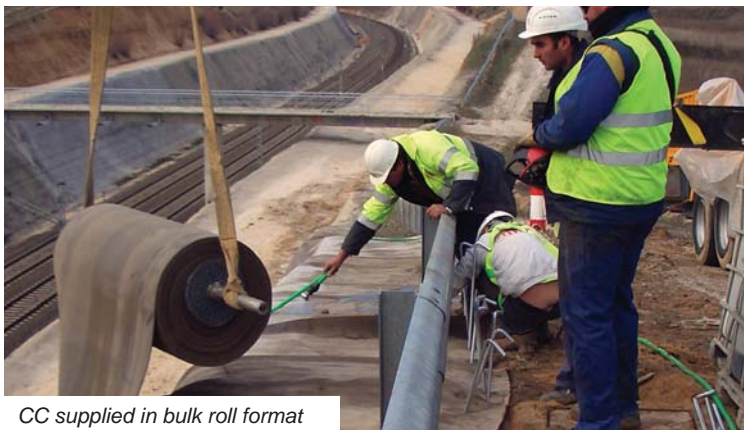
CC supplied in bulk roll format

CC8 was specified and 2500sqm of material was delivered on site in bulk rolls. The project's first phase of 800sqm was completed in under 3 days and was 70% quicker to install than if shotcrete had been used.

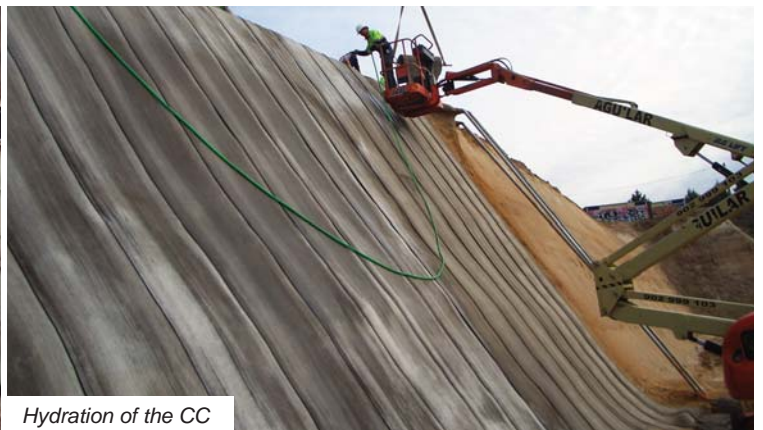
Hydration of the CC

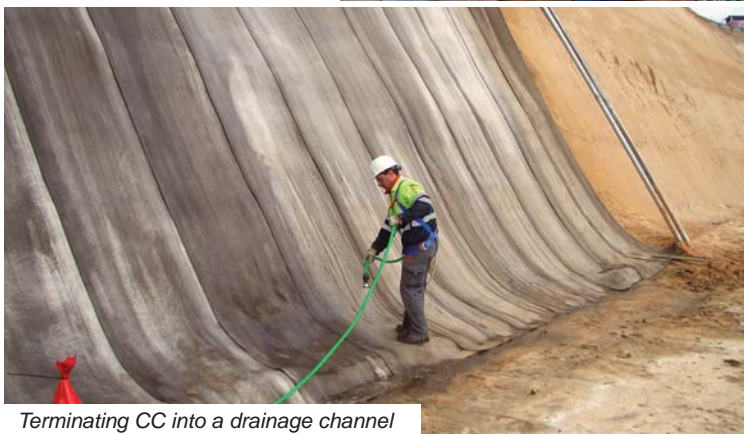
Terminating CC into a drainage channel

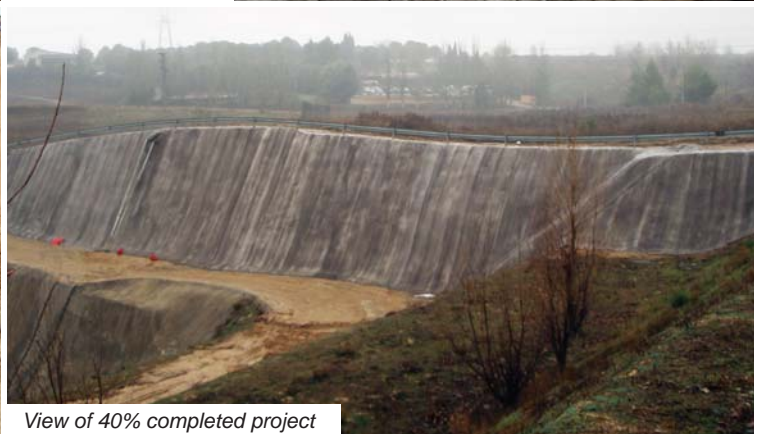
View of 40% completed project

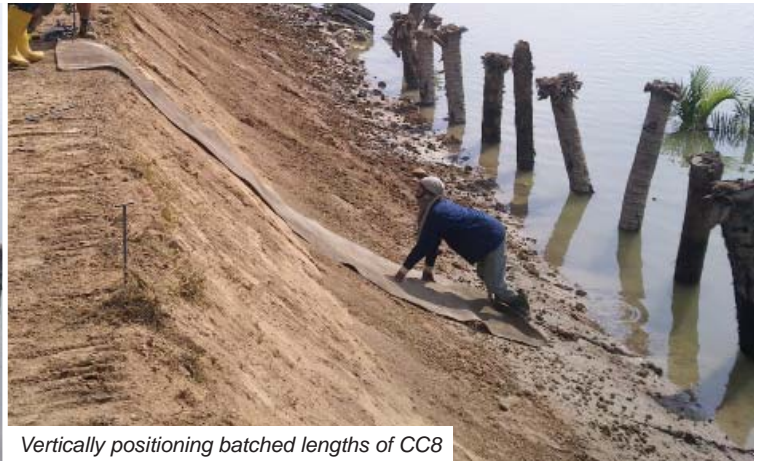
Vertically positioning batched lengths of CC8

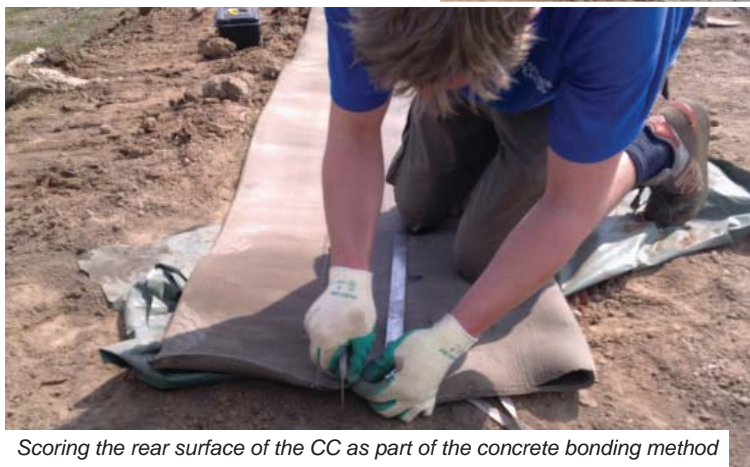
Scoring the rear surface of the CC as part of the concrete bonding method

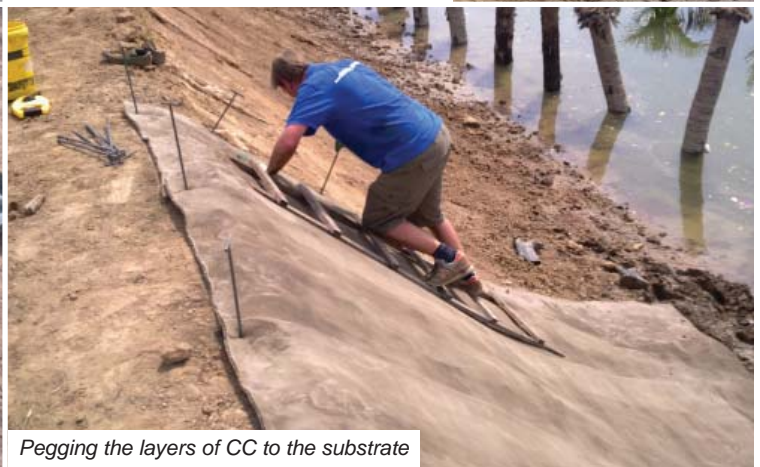
Pegging the layers of CC to the substrate

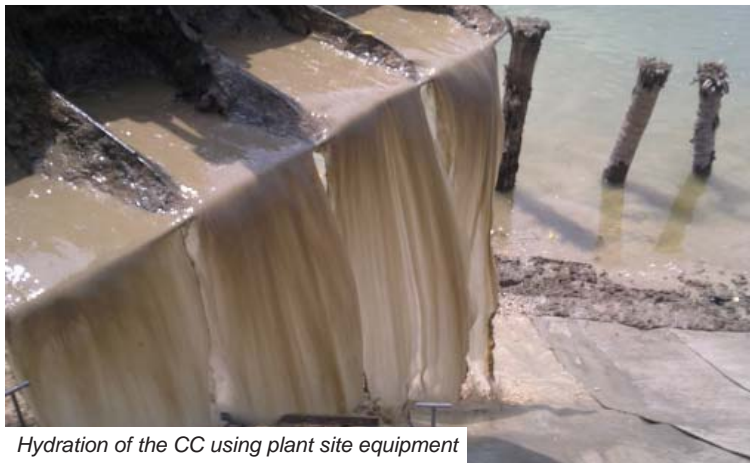
Hydration of the CC using plant site equipment

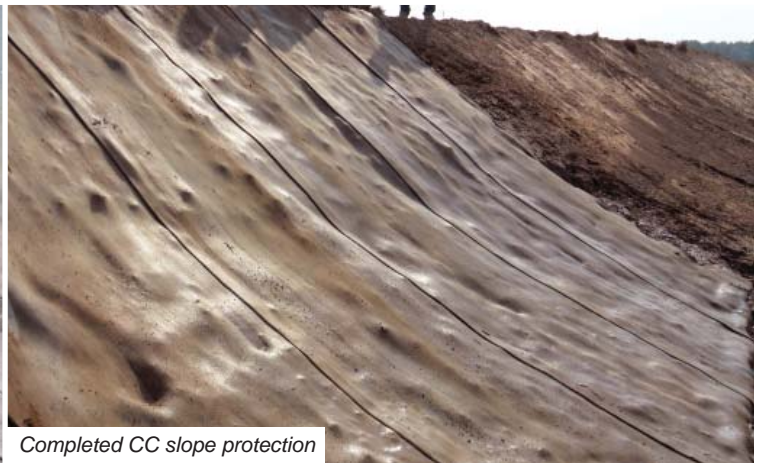
Completed CC slope protection

Early indications show that the CC is preventing any further erosion to the embankment and is a cost-effective and easy to install form of slope protection for this site.

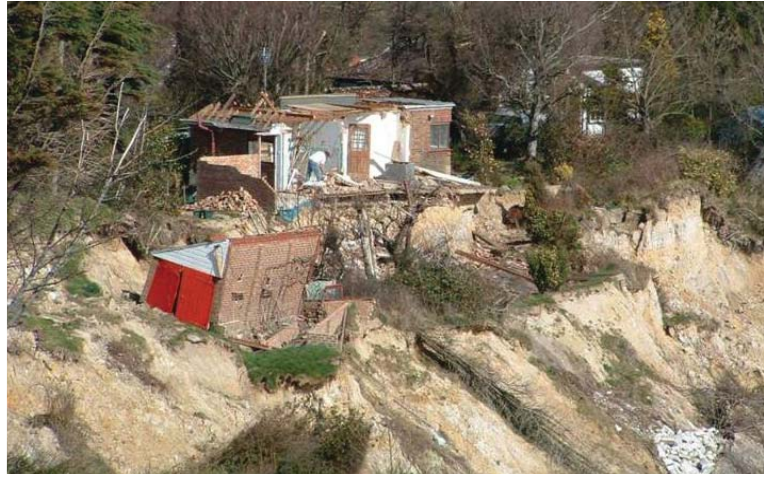
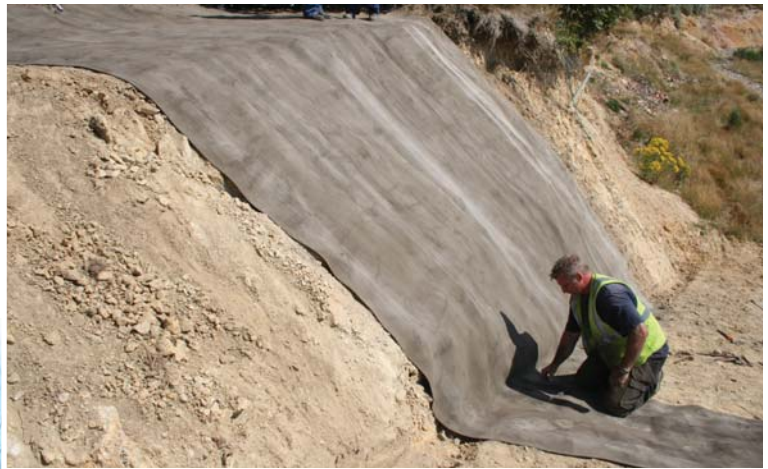
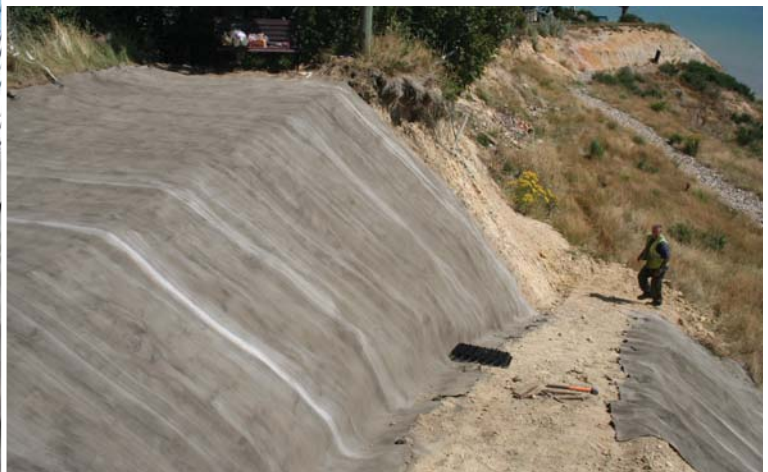
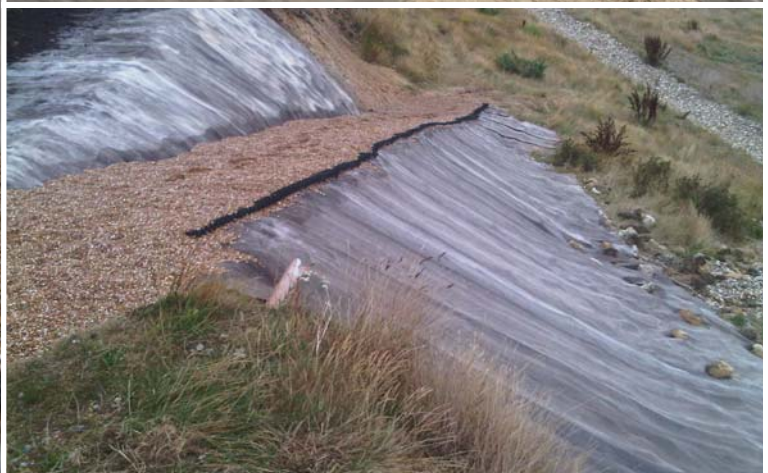
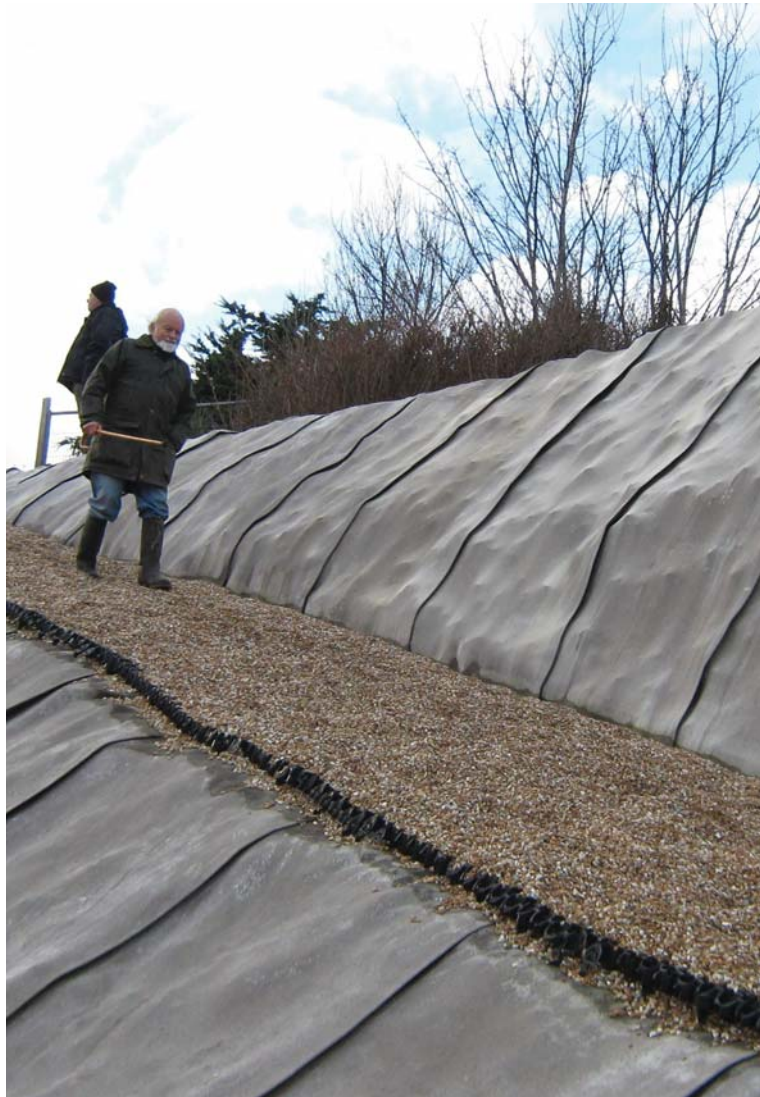
CC4 (4mm Concrete Cloth) was specified by Rother Council's geotechnical consultants to stabilise and protect a sub-vertical failure surface close to a key drainage facility. The steep nature of the slope prevented conventional slope stabilisation techniques such as vegetation growth. The Cloth was supplied as man-portable rolls allowing work to be completed in areas with restricted access and where conventional concreting would be impossible.

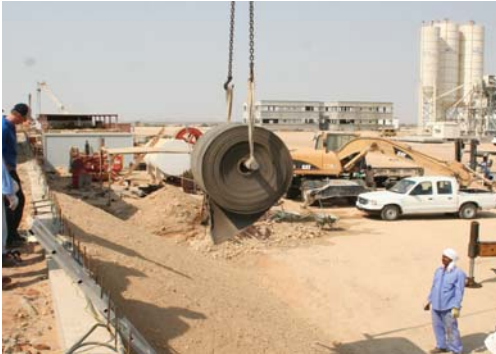
CC4 or CC8 in rolls of 200sqm or 125sqm respectively can be handled & positioned using site plant.

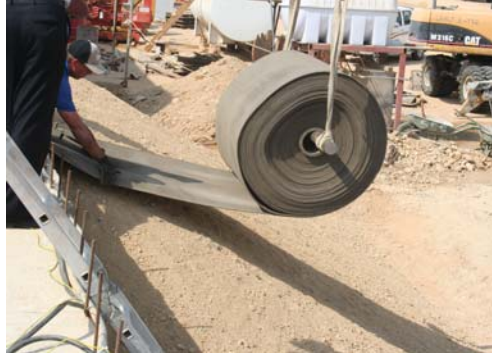
CC is rolled from the slope crest down the slope face, with 100mm overlaps between adjacent CC sheets.

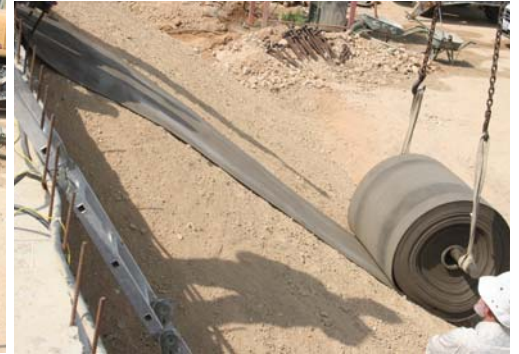
CC is cut to length, depending on the slope size.

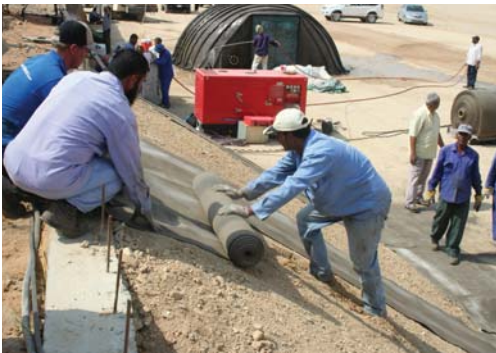
Short lengths of CC can be provided in man portable lengths for manual application.

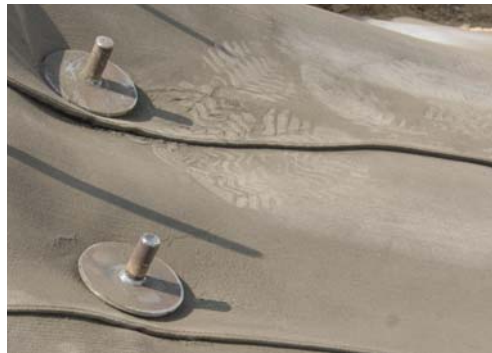
CC is fixed using short nails hammered into the soil. Other fixing methods such as drilled bolts can also be used if rock is present.

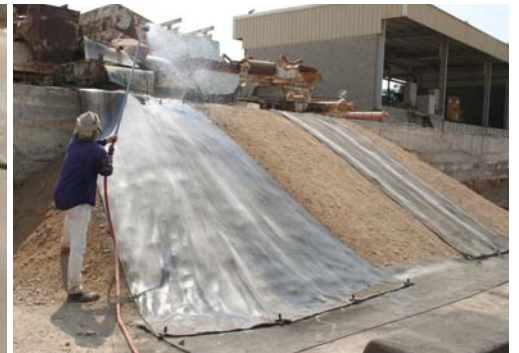
CC is hydrated once fixed into position. Lined drains can be formed from CC at the slope crest and toe.
